Project: Power Generation Plant

The Problem

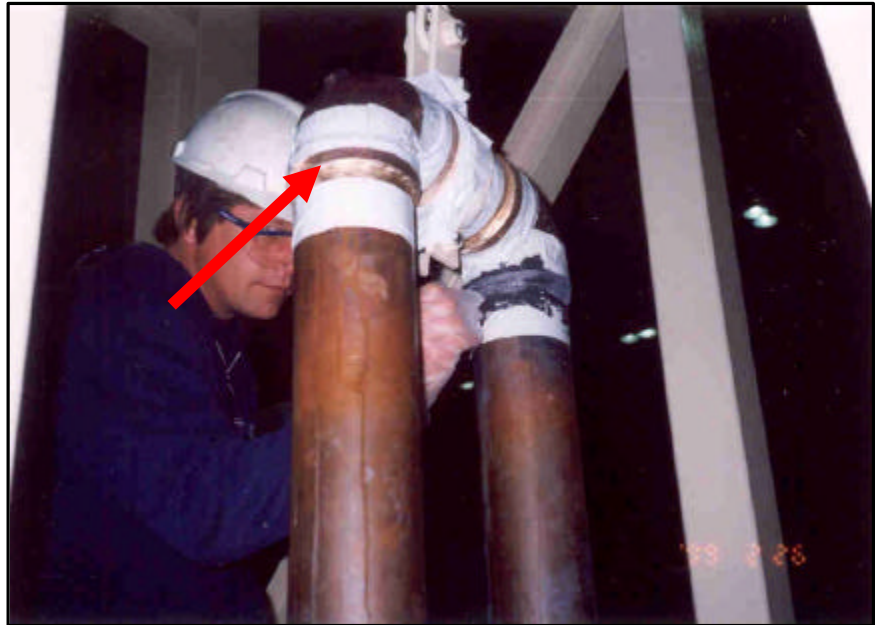
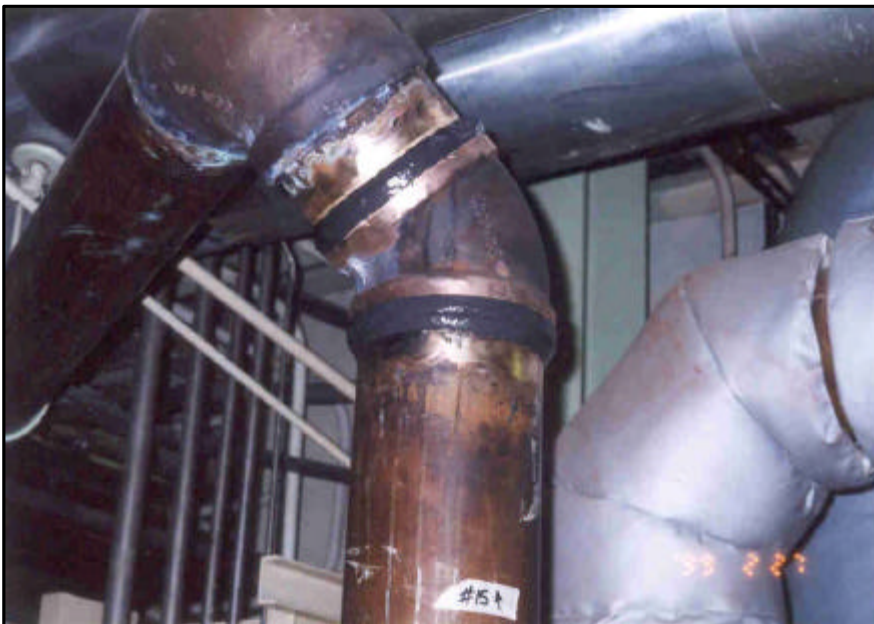
This Power Generation Plant was getting diminishing UT readings for these welds in their non-safety related piping.

RPT and Thortex came up with a solution which required abrasive cleaning of the joint weld. We then taped off the area and applied 250 mils of **Thortex Metal-Tech XG** to reinforce the weld.
