Project Profile Tipping Room Floor

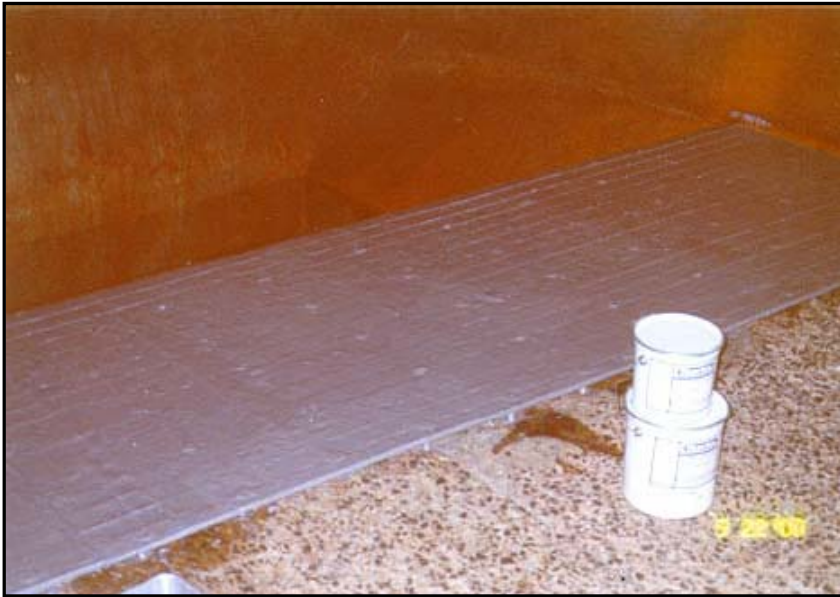
The tipping room floor of this 4-year-old, 1,200 ton-a-day transfer station has had over 6" of its concrete floor eroded by front end loader traffic. The exposed rebar caused damage to the tires, while open joints allowed leachate and other liquids to permeate the substrate.

The entire 1,600 square foot area was cleaned, steamed, degreased and the salts chemically removed. The exposed rebar was protected by **Corro-Tech GP**, which provides an anti-corrosive, long-term protection to existing steel structures.

The area was filled and leveled to its original height using **Floor-Tech RS**. This 100% solids epoxy has a compression strength of 12,500 psi and is extremely resistant to a wide array of chemicals.
