## Project: Emergency Pipeline Leak Repair

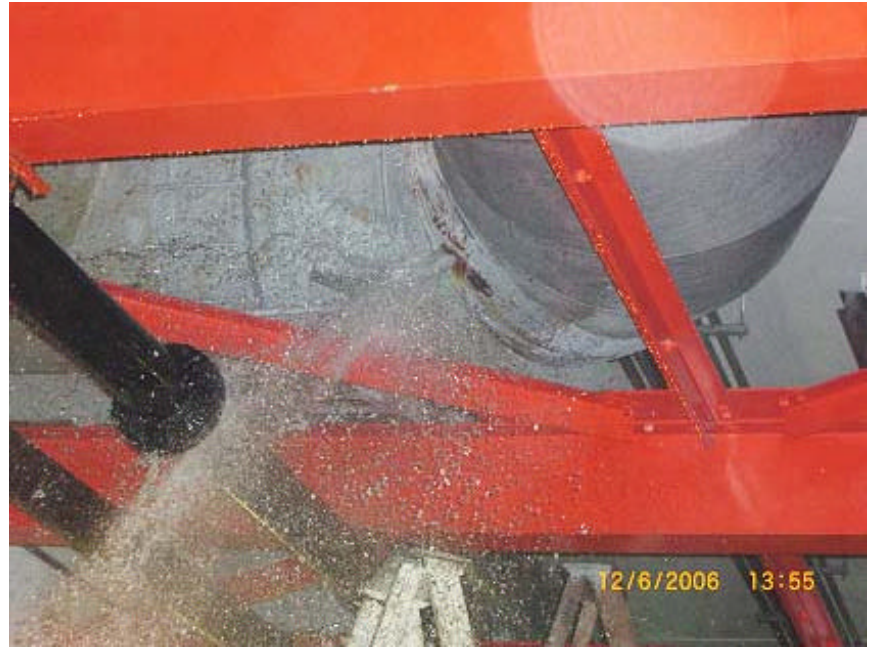
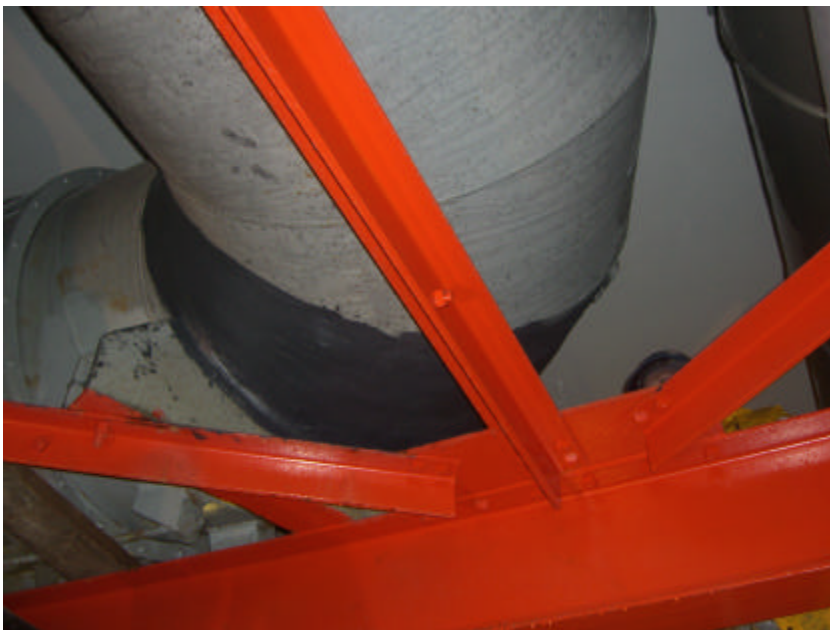
This 48" forced main at a Waste Water Treatment Plant had sprung this large leak and several smaller leaks.

Once the pump was shut down, RPT manually cleaned the pipe surfaces to a SSPC-SP10 finish.

A metal plate was manufactured to cover the leak area and **Thortex Metal-Tech EG** used to fix it in place. A reinforcing metal band was used to secure the repair plate and 250 mils of **Thortex Metal-Tech XG** was then applied. Reinforcing mesh was embedded into the product followed by another 250 mils of **Thortex Metal-Tech XG** and an additional layer of reinforcing mesh.

A 30 mil top coat of **Thortex Cerami-Tech FG** was applied to protect the pipe against future impact and chemical damage.
