## Project Profile

# Skylight Replacement and Flashing

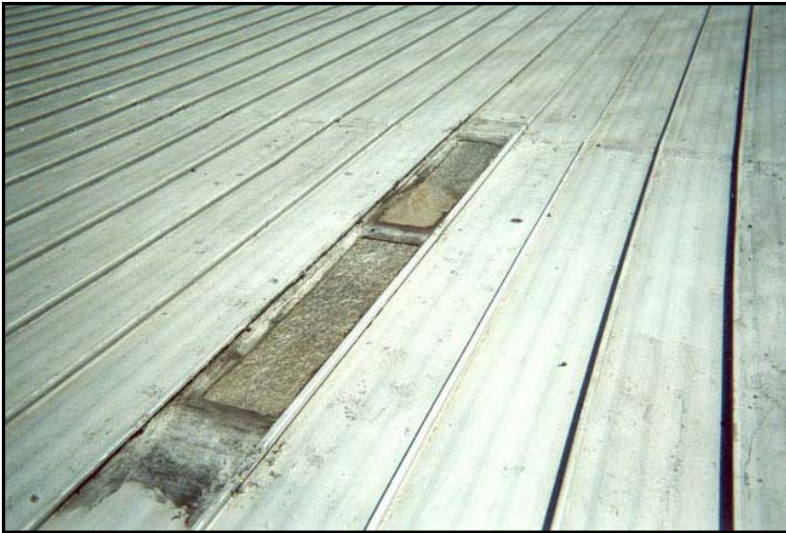
The existing fiberglass skylight lenses were deteriorated and leaking at the perimeters.

Numerous attempts at repairs had no lasting effect.

The surface was coated with a base coat of Poly-Tech Elastomeric Roof Coating.

Reinforcement mesh was embedded into the Poly-Tech.

A top coat of Poly-Tech was then applied to the entire area, resulting in functional, water-tight application.
