PROJECT PROFILE

PROJECT: CONCRETE BUND PROTECTION

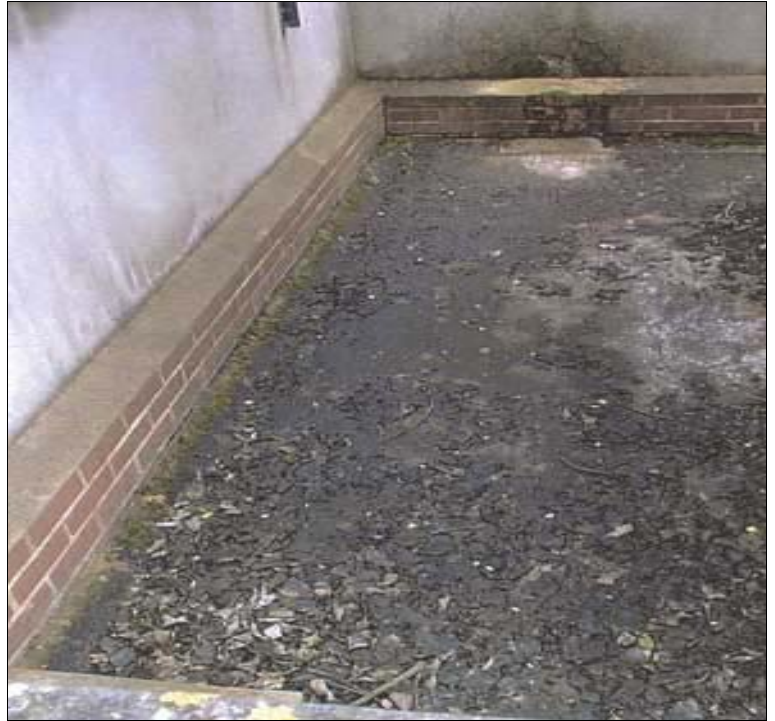
The concrete bund shown in this photograph had leaked resulting in diesel contamination of a nearby nature pond. The Environment Agency became involved and the client was held responsible for the clean-up operation.

The bund area was steam cleaned to remove all diesel oil and then pressure washed. All surfaces to be coated were primed with Floor-Tech SP Primer and then Chemi-Tech CR was applied.
