PROJECT PROFILE

PROJECT: POTABLE WATER TANK REFURBISHMENT

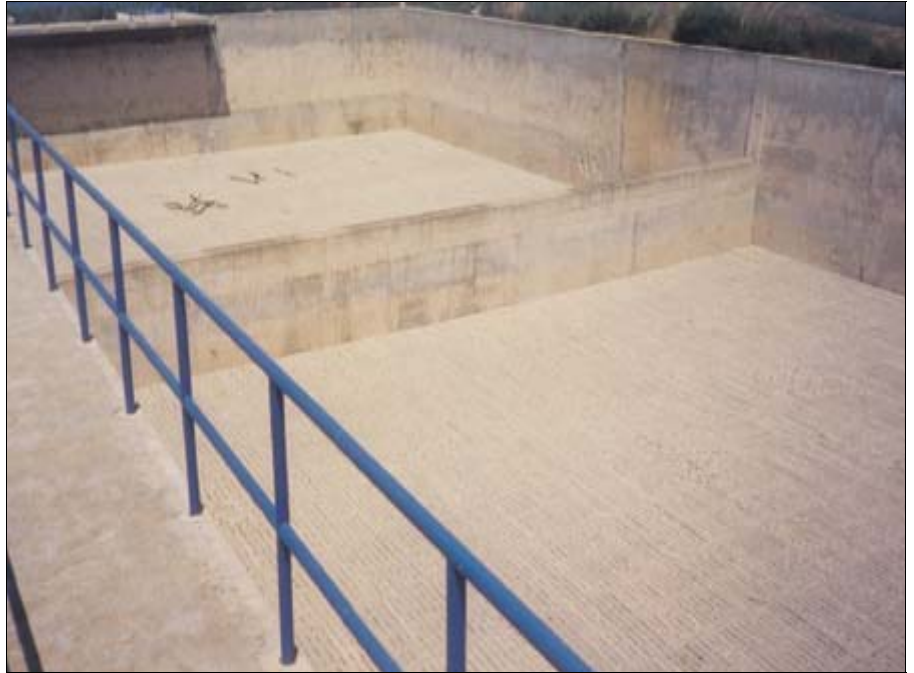
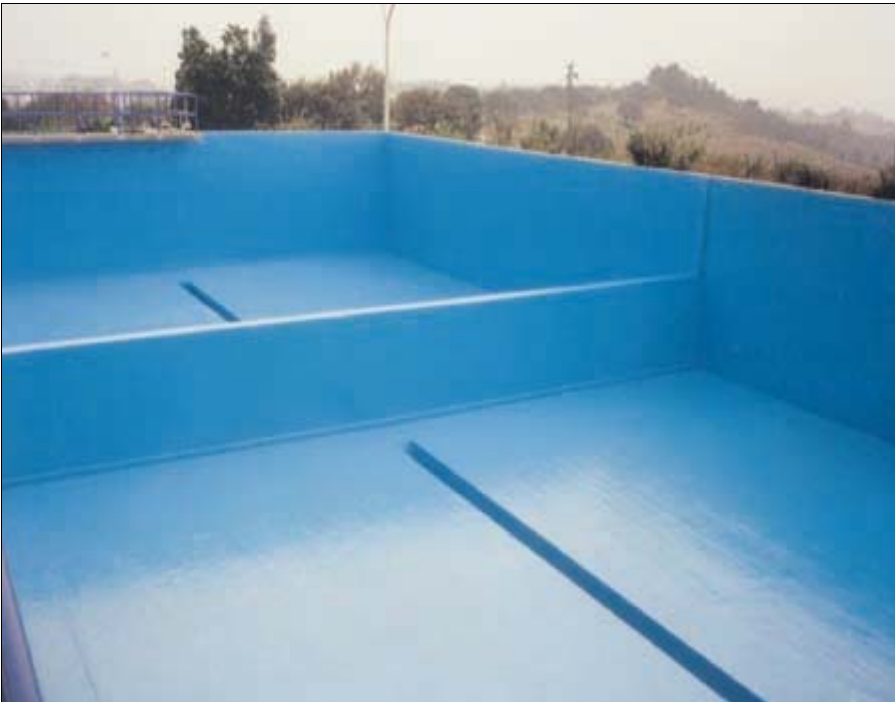
The tank depicted in the photograph is used to filter potable water. It was very old and had deteriorated over time to the extent that cracks had begun to appear in several places causing water leakage.

The entire tank was in need of a complete refurbishment.

The tank was drained and completely cleaned out. All cracks were suitably prepared and filled with our repair mortar Wall-Tech LW. All internal surfaces were then primed using Floor-Tech SP followed by one coat of 162 PWX.

162 PWX is a solvent-free, fast-curing polyurethane coating approved for contact with potable water by the USDA/FDA.
