## Project: Northeast Power Plant Air Intake Plenum

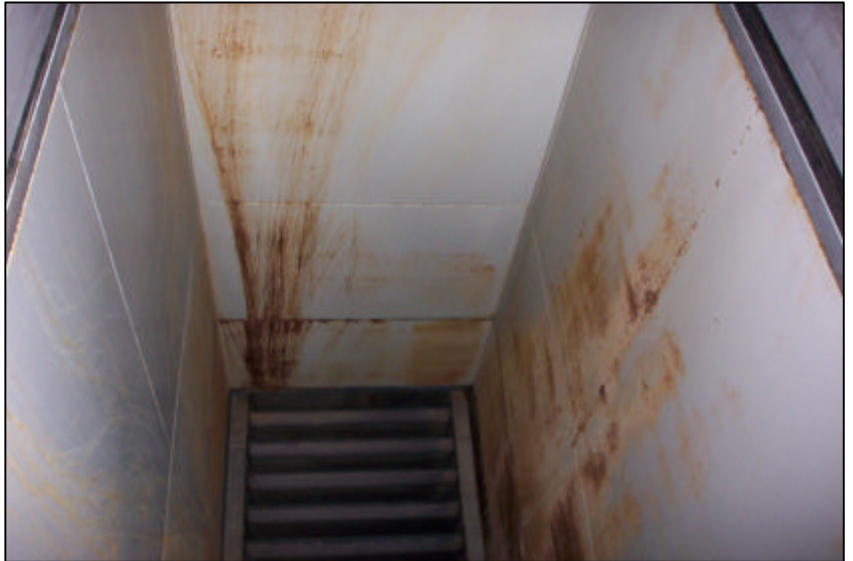
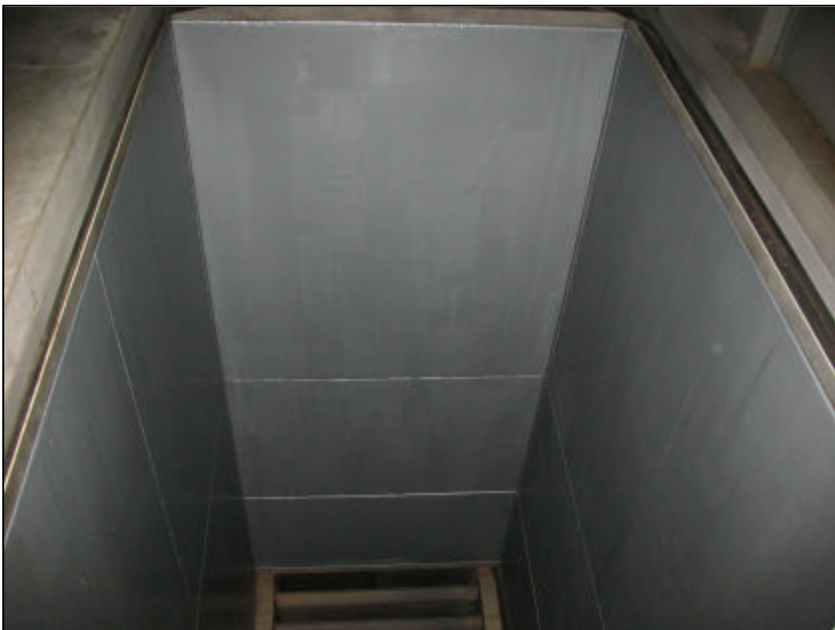
This Power Plant's Air Intake Plenum was experiencing corrosion due to the environment in which it operates.

After completely protecting the intake from any dust and debris, **RPT** started by manually abrading the surfaces to remove loose coating, mill scale, and flaked/packed rust and vacuuming the loose debris and dirt.

The **Thortex Corro-Tech GP** system was chosen for this project because of its high performance chemical and corrosion resistant properties and its outstanding adherence in areas subject to moisture, heat and abrasive elements such as dust and ash.
