Project: Corroded Recirculation Pump

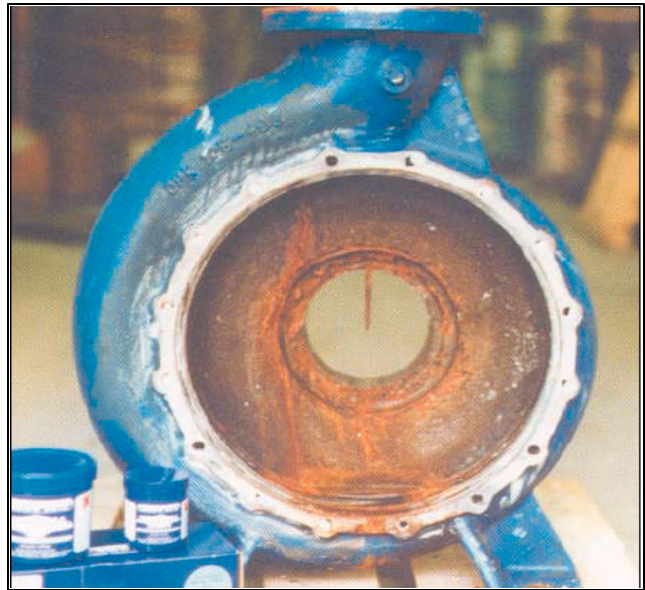
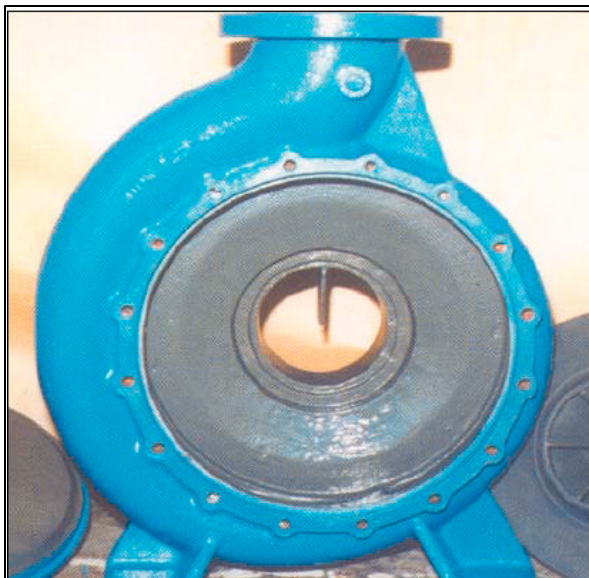
This severely corroded and rusted recirculation pump was taken out of service due to diminished flow.

RPT removed the rust and corrosion and then used **Thortex Metal-Tech EG** to repair and rebuild the component.

RPT then coated the repaired pump with **Thortex Cerami-Tech FG** to protect it against further damage.
