## Project Profile Off Road Tire Repair

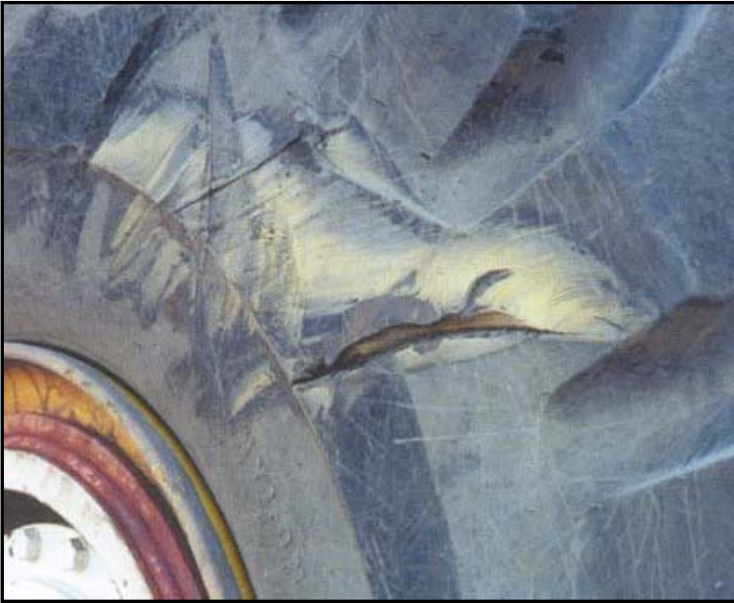
This tire has suffered deep damage due to a heavy impact.

Due to the replacement cost for a new tire and the length of downtime required, the company wanted to undertake a high performance repair instead.
