Project: Refinery Underground Pipe Repair

The Problem

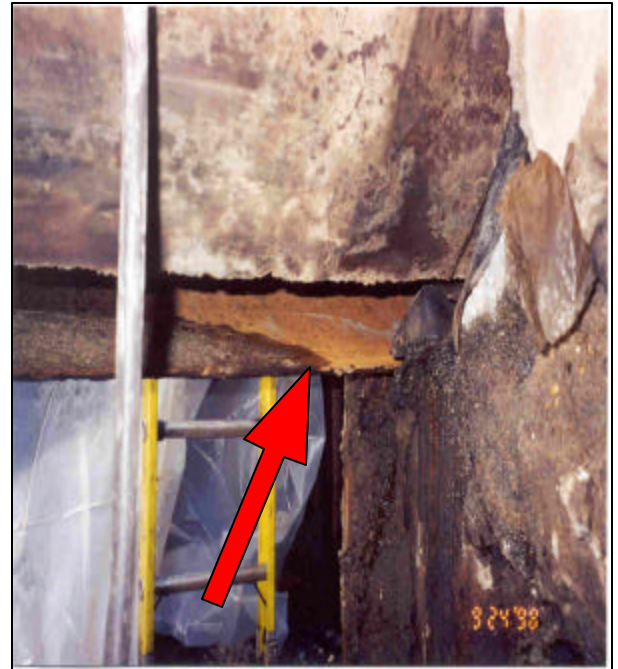
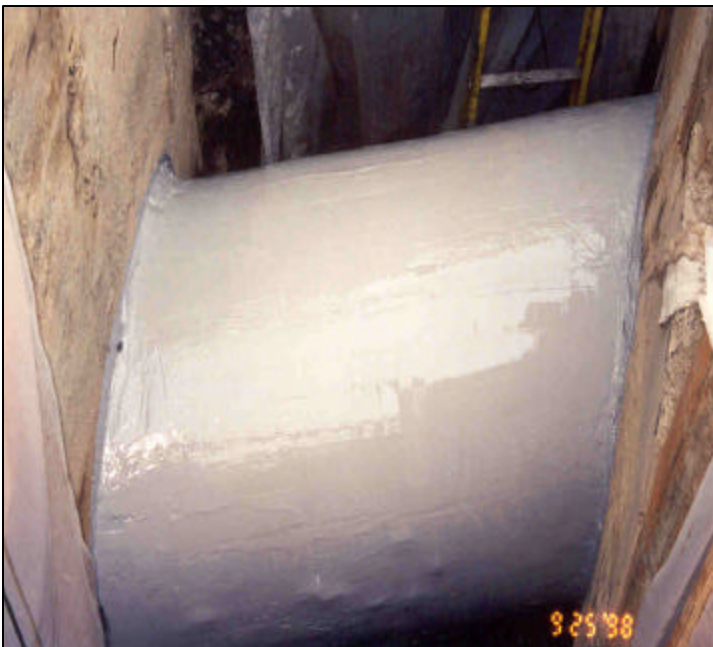
This refinery had a 48" diameter underground pipe with a large, gaping hole on its underside.

RPT manufactured forms to replicate the exact configuration of the underside of the pipe and then abrasive blasted and coated the pipe with **Thortex Chemi-Tech CR**

Thortex Metal-Tech EG was applied to the edges of the forms to act as an adhesive to affix them to the pipe and seal the edges. Straps and reinforcing mesh were also used to hold the forms in place.

One coat of **Thortex Cerami-Flex EG** was applied over the mesh and straps. Additional coats of **Thortex Cerami-Flex EG** were then applied to completely encapsulate the mesh and straps.

A final coat of **Thortex Cerami-Flex FG** was applied to the entire pipe at an average of 240+ mils.
