PROJECT PROFILE

PROJECT: Power Generation Station Pump Repair

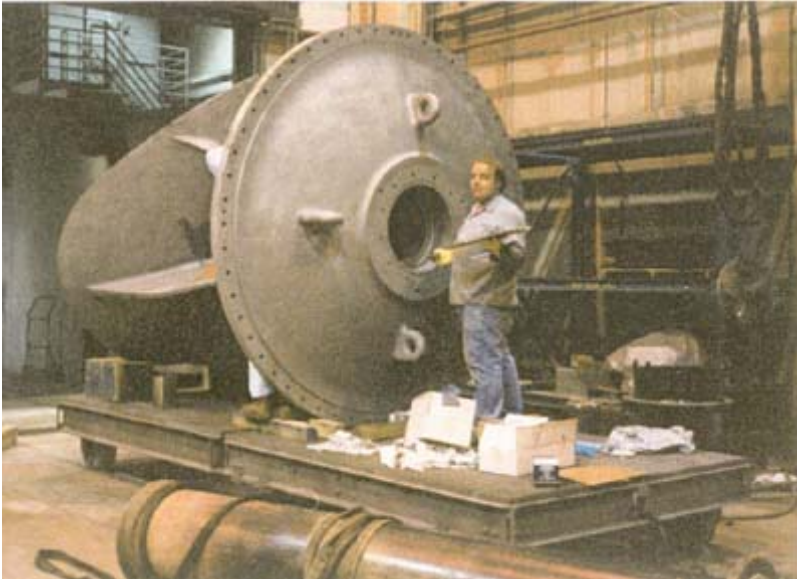
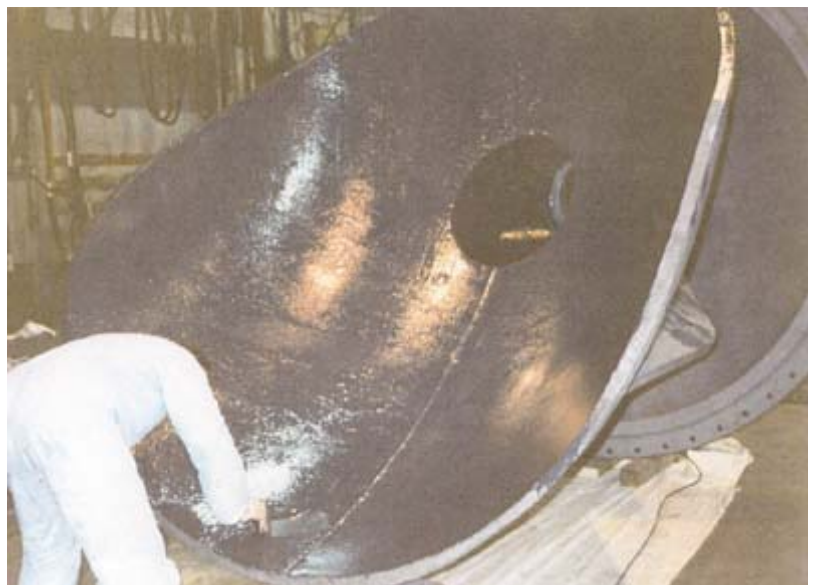
A large Power Generation Station on the east coast had a major problem with one of their main circulating pumps.

The pump had been coated with a higher-cost competitive product which had started to delaminate and wear after only 6 months in operation.

The entire pump assembly was removed, dismantled and cleaned. Machined surfaces were protected then all components to be coated were abrasive blasted to a near white finish. Two coats of Cerami-Tech FG were applied by the facilities' own maintenance staff supervised by a Thortex representative.

The main shaft was also repaired using Metal-Tech EG. The pump has been in service for over 4 years with no visible sign of wear.
