PROJECT PROFILE

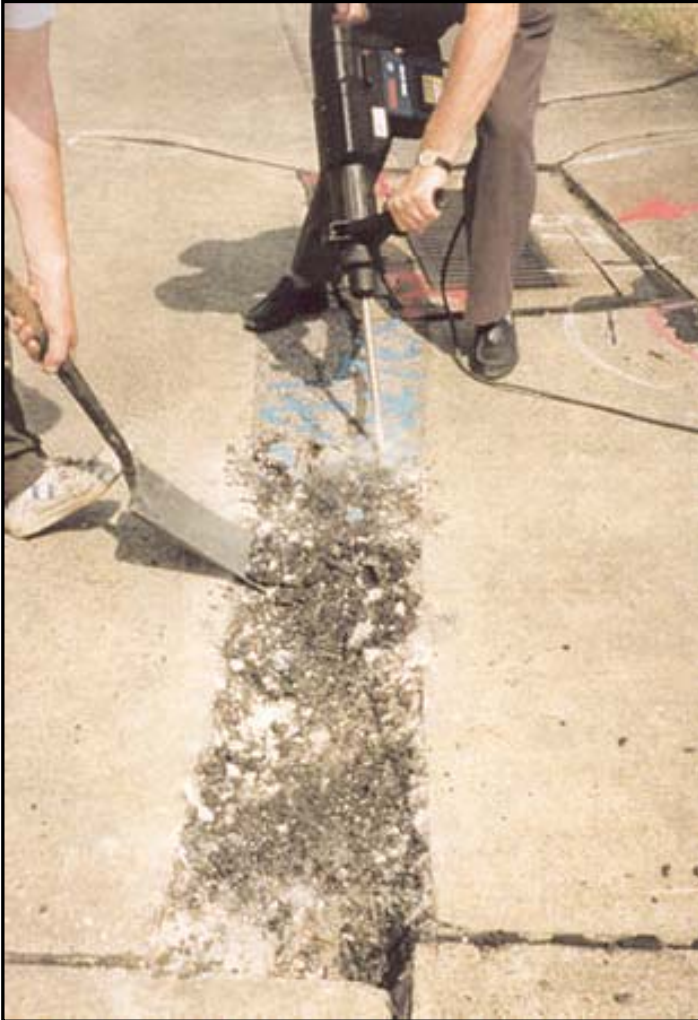
The runway was suffering from the general breakdown of corner edges and joints due to wear and tear overtime.

To meet military requirements, all repairs had to be squared off to prevent the possibility of any "foreign object bodies" breaking away and causing damage to the airplanes.

The edges were cut out to remove all loose concrete and squared off. The expansion joints were constructed and filled with Flexi-Tech 80. The runways were repaired with Floor-Tech PR.
