PROJECT PROFILE

PROJECT: Shower Block Refurbishment

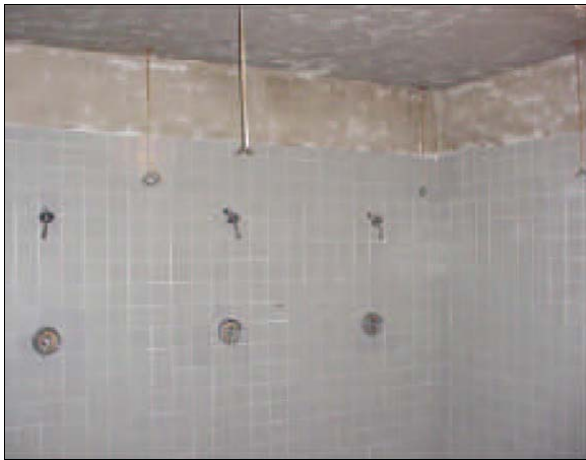
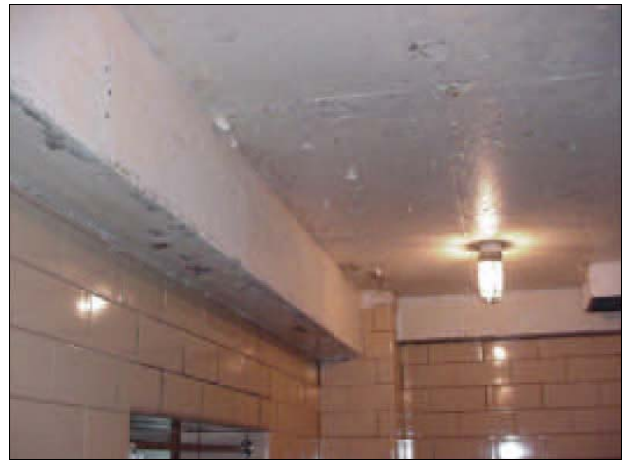
These showers, after years of use and attempts to paint over a problem, needed an upgrade.

The ceiling was grit blasted to remove multiple layers of coatings, and to get sound substrate. Spalled areas were repaired with Wall-Tech LW. After preparation of the walls and floors, per Thortex recommendations, the entire area was refurbished using Wall-Tech UV. The floor was made a different color to break up the appearance, and to add contrast to the area. The customer is considering doing quite a few more of these, and individual showers as well.
