## Project: Waste to Energy Plant

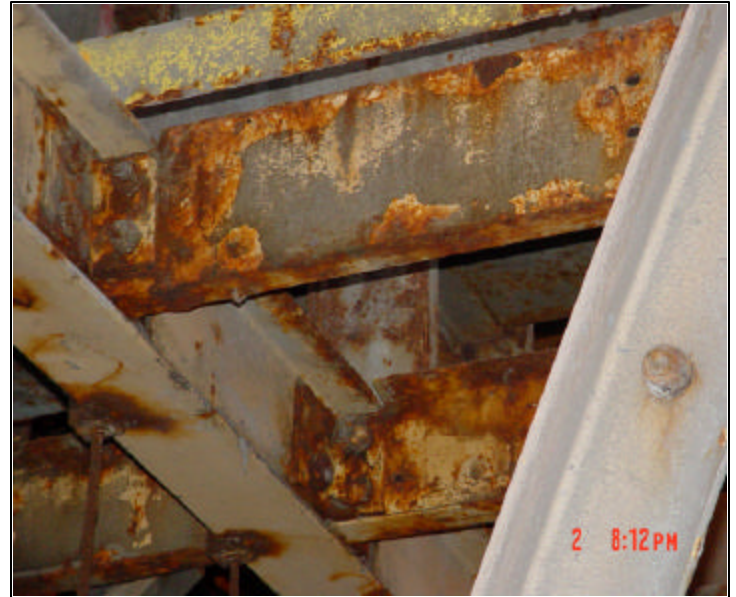
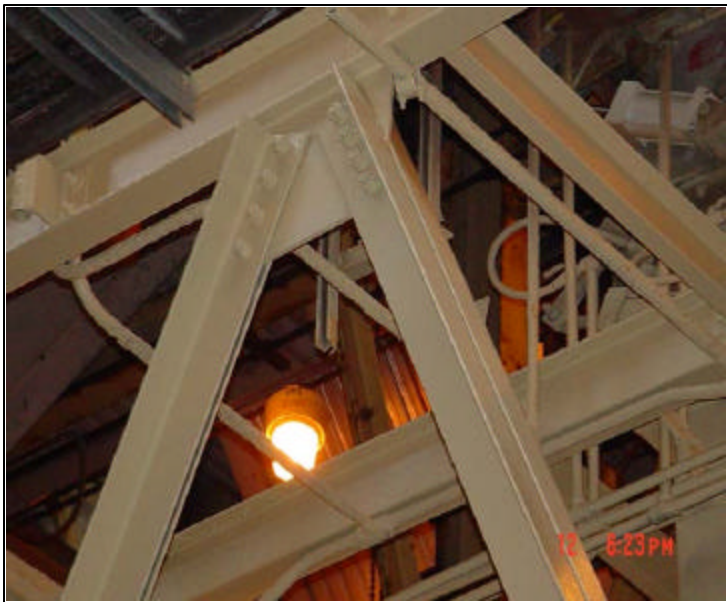
The structural steel in this waste to energy plant showed severe damage from corrosion.

The steel was sweep blasted and pressure washed to remove all of the flaking and peeling coating and packed rust. Two coats of **Thortex Corro-Tech GP** were applied to prevent future corrosion and then a final coat of **Thortex Poly-Nox** - in a custom color matched to the client's specifications - was applied.
