Profile: Structural Steelwork

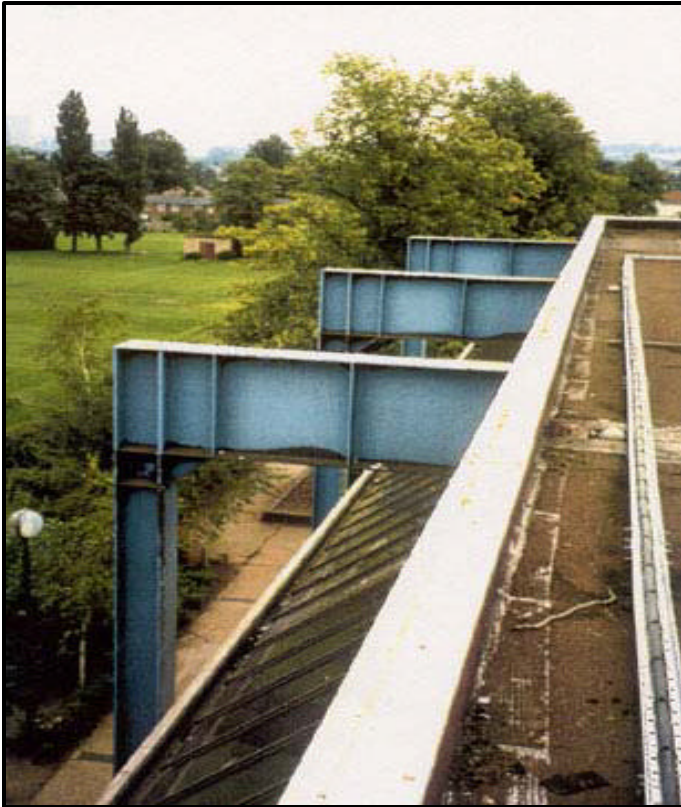
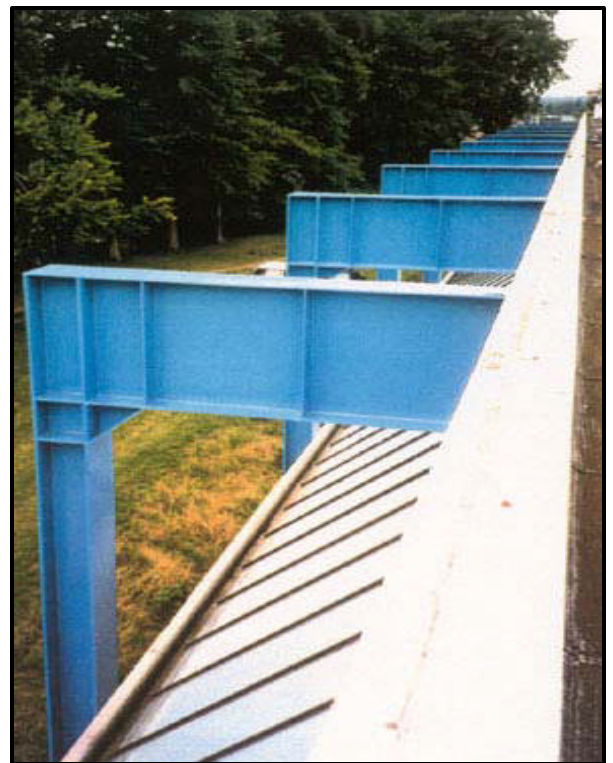
The existing coating on the steel columns was debonding from the steelwork. This caused the exposed steel to corrode.

The surface of each column was prepared by removing all loose and flaking paintwork.

The columns were then patch primed with **Thortex Corro-Tech GP**. One full coat of **Thortex Corro-Tech GP** was then applied followed by two coats of **Thortex Uni-Tech UV**.
