## Project: Northeast Transportation Center

### The Problem

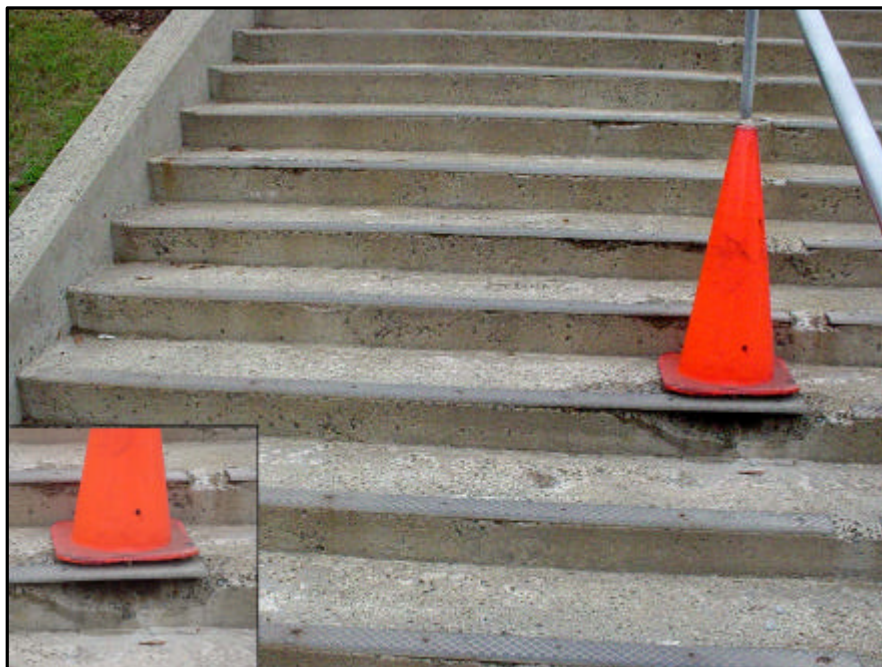
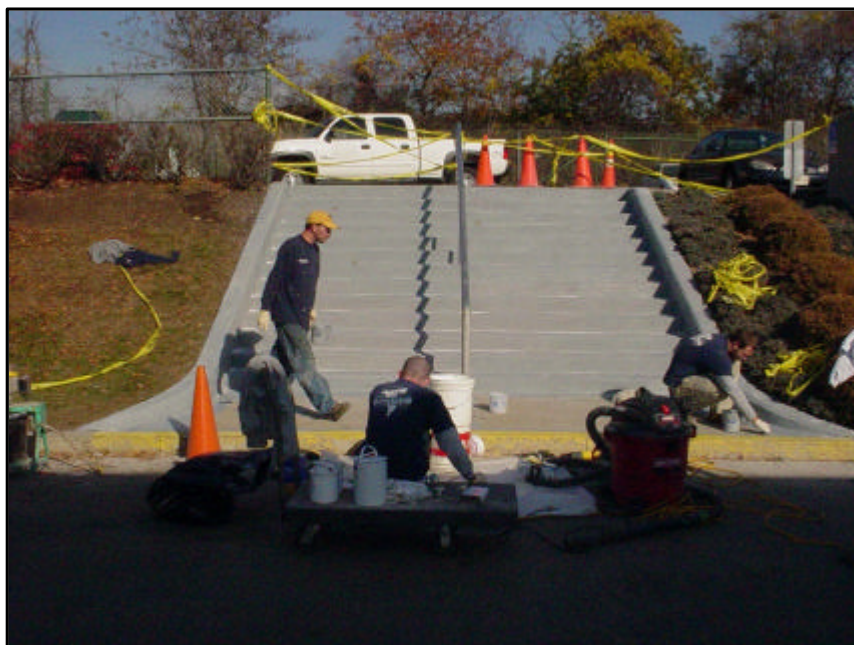
The stairs at this transportation center parking lot were severely damaged by weather and normal wear and tear. The company was eager to restore them to good condition. They wanted to prevent accidents. (Note the severe deterioration at the metal tread plates.).

RPT high pressure washed the concrete surfaces to remove all dirt, oil, contamination and loose debris. Then the chlorides had to be removed before the repair / coating process could begin..

The surfaces to be repaired were primed with **Thortex SP Primer** and rebuilt with **Thortex Floor-Tech RS**.

All existing coatings were removed, the entire surface primed with **Thortex SP Primer** and then two (2) coats of **Thortex Floor-Tech PU** were applied with a non-slip aggregate being incorporated into the first coat and then sealed in with the second coat.

**Thortex Floor-Tech PU** was chosen because of it's tough, durable finish that has excellent abrasion, impact and UV resistance.
