Project: WWTP Concrete Digester

The Problem

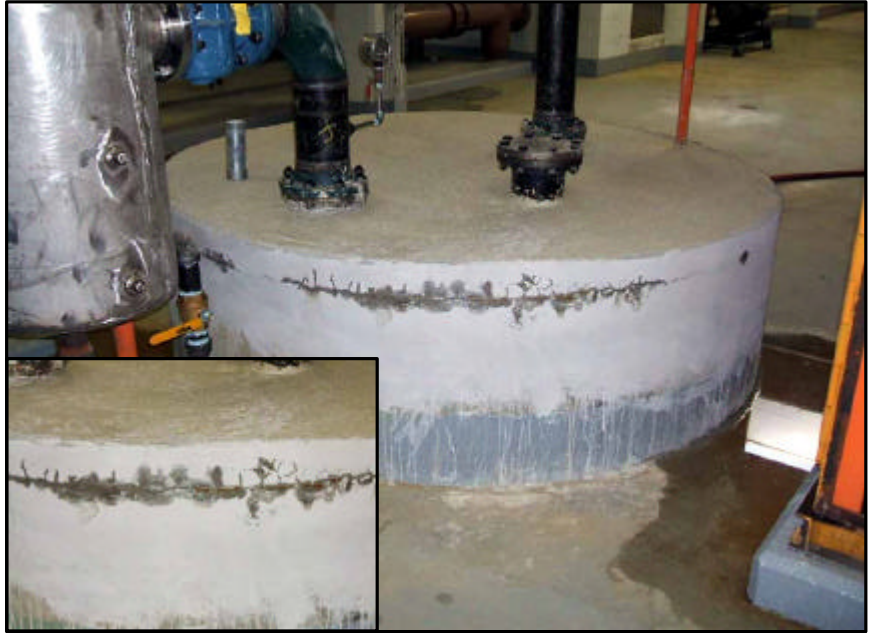
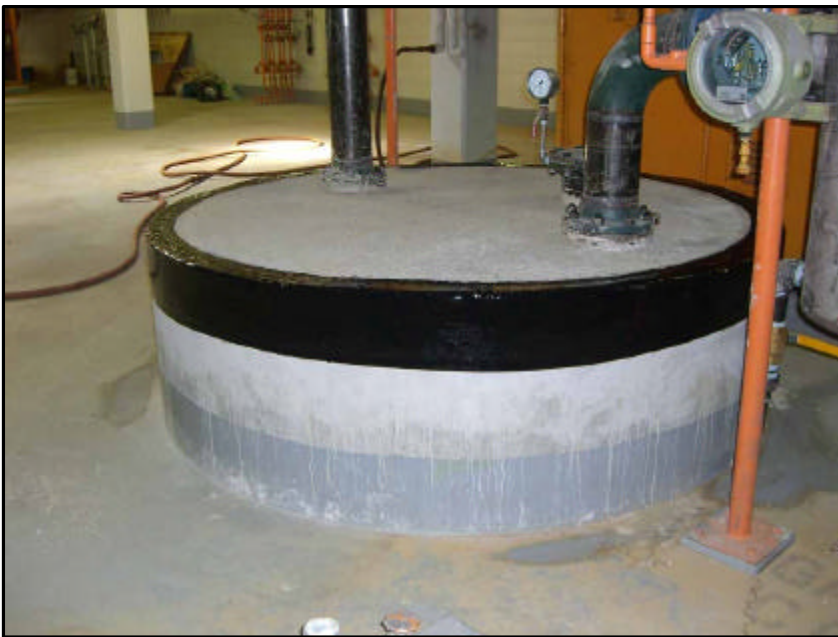
This WWTP's digester cracked and methane gas was leaking into the atmosphere. They needed an emergency repair and called Repair and Protection Technologies for help.

After cleaning the surface with a non-residual solvent, we repaired the crack with **Thortex Metal-Tech RG**.

Once the gas was contained, we wrapped the entire structure with 10mm of **Thortex Metal-Tech EG** and two (2) layers of embedded mesh. We completed the project by top coating with **Thortex Flexi-Tech 80 EG** to add additional impact resistance in this high traffic area.
