## Project: WWTP Digester Lids Repair

### The Problem

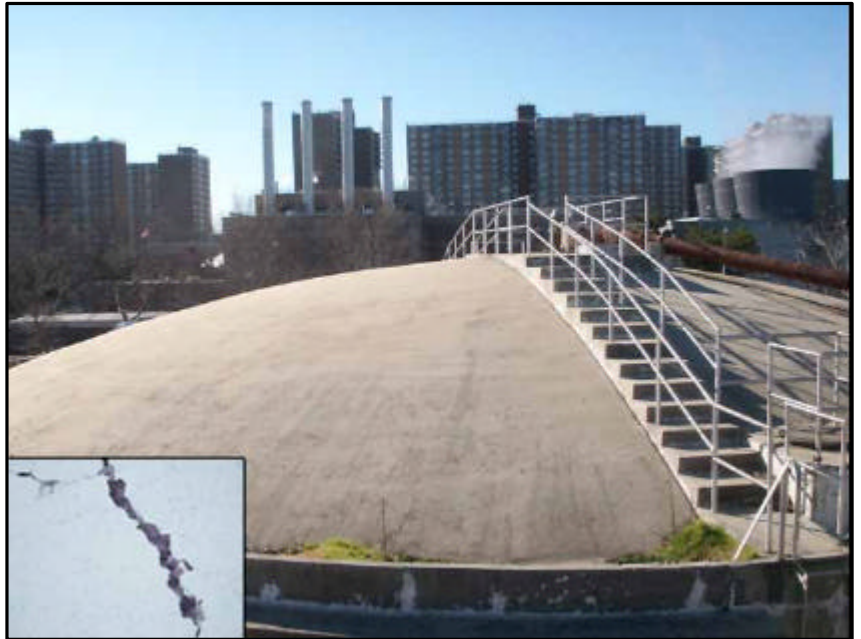
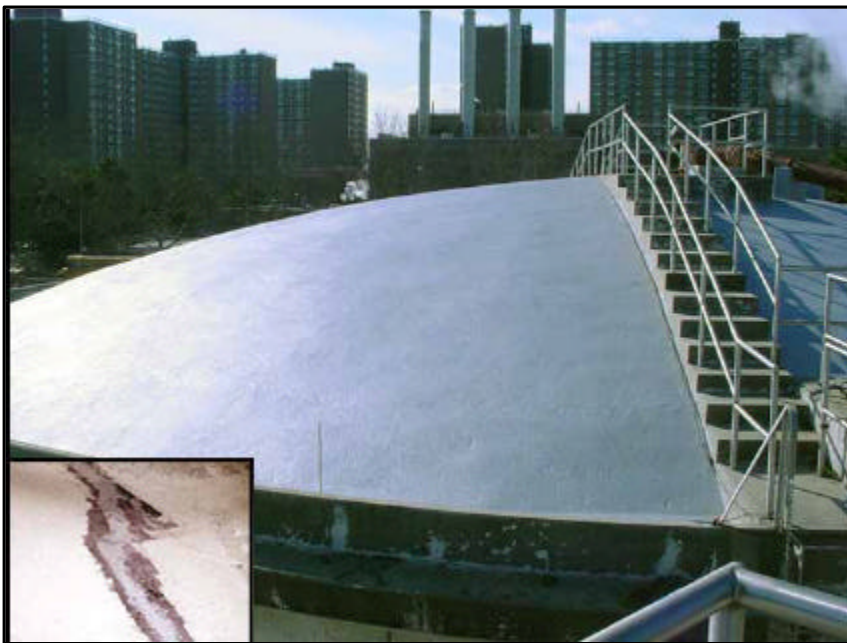
The digester lids at this WWTP were cracked and leaking methane gas. The preferred solution was to fix the lids while the digesters were operational.

This posed a problem since methane gas is notorious for interfering with the ability of cementitious products and most epoxies to cure.

RPT came in and pressure washed the lid surfaces to remove all oils, grease and organic contamination.

The large cracks were filled with the **Thortex Flexi-Tech** system which can cure while fully immersed in liquids. The metal lid penetrations had two (2) coats of **Thortex Corro-Tech GP** applied to abate future corrosion.. The entire lid surface was then coated with two (2) coats of **Thortex Poly-Nox**. **Poly-Nox** was chosen because of its ability to bridge and fill cracks up to 125 mils (1/8 inch) and for its elastomeric properties.
