Project: 54" Pipe Wrap

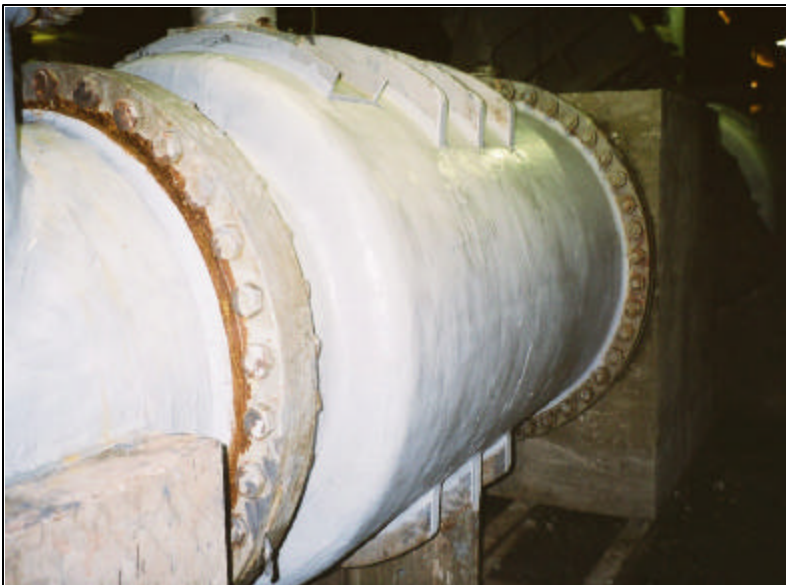
This WWTP's main in flow pipe – carrying 350 million GPD - had ruptured in several small areas.

RPT applied **Thortex Cerami-Flex EG** at 120 mils over the prepared pipe surfaces. Nylon mesh was imbedded in the wet **Thortex Cerami-Flex EG**. A second coat of **Thortex Cerami-Flex EG** was applied at 60 mils over the meshed surfaces.

A final topcoat of **Thortex Cerami-Flex FG** was applied at 40 mils. The finished system was at 240+ mils.
