## Profile: Concrete Repair & Protection

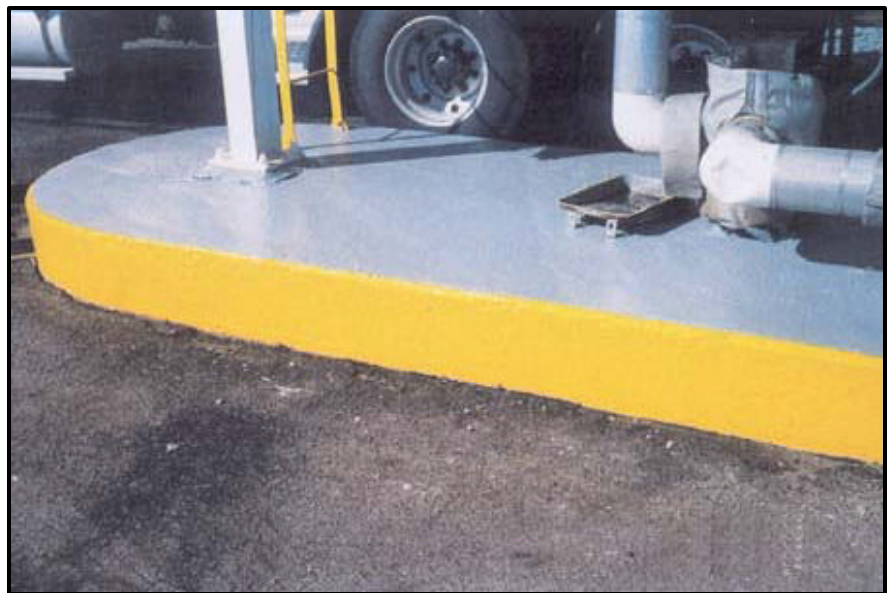
The project was to completely repair the concrete and coat the surface to provide protection against chemical attack.

The damaged concrete was reinstated using **Thortex Floor-Tech RS**. The entire concrete surface was coated with **Thortex Floor-Tech SP Primer**, the metal areas with **Thortex Uni-Tech MC Primer**, over which **Thortex Chemi-Tech CR** was applied.

Our safety surfacing system, **Thortex Grip-Tech**, was used for the edges of the islands.
