Project: Cooling Tower Supports

The Problem

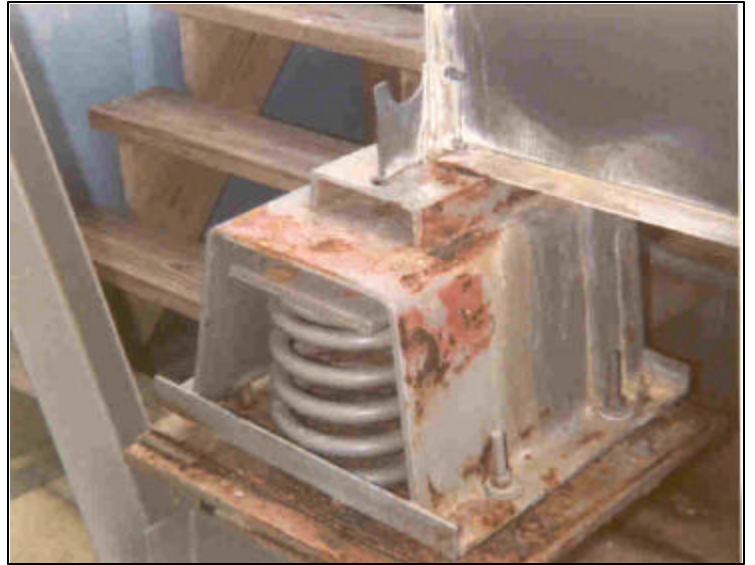
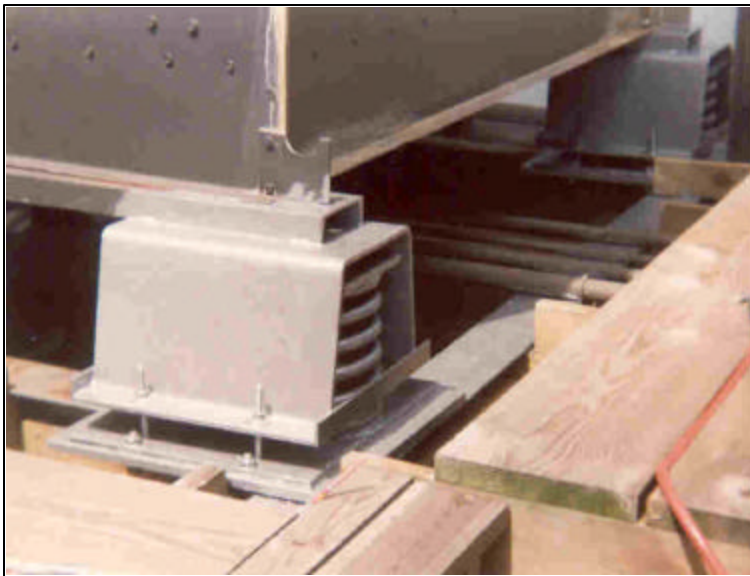
These cooling tower supports were corroding from environmental effects as well as salts and chlorides.

RPT pressure washed the supports and coated them with two coats of **Thortex Corro-Tech GP** followed by a top coat of **Thortex Poly-Nox**.

RPT used the same system on 30 more supports for this customer over the last 5 years with no system degradation.
