## Project: Water Treatment Plant Dam

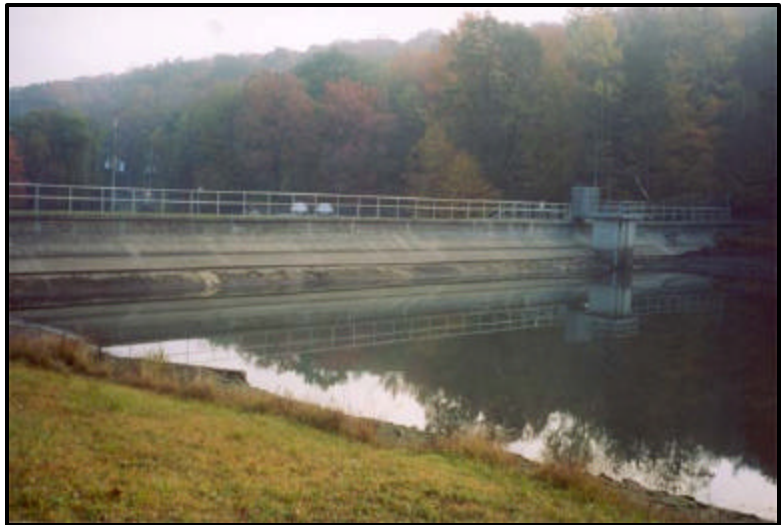
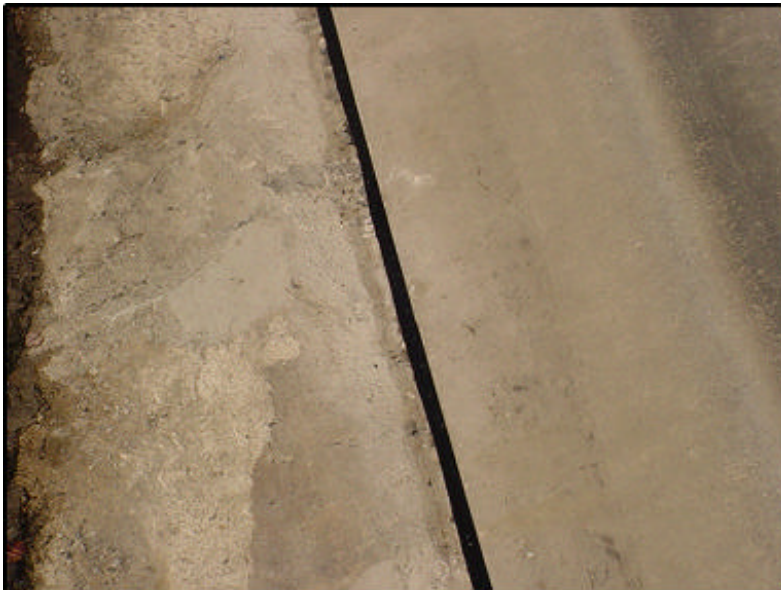
This water treatment plant had water infiltration through their dam and subsequent erosion of the support fill.

This authority chose RPT and Thortex to replace over 1100 linear feet of joint with **Thortex Flexi-Tech 80 EG**.

**Thortex Flexi-Tech 80 EG** is a solvent-free, paste-grade elastomer that is applied by trowel or putty knife and possesses outstanding mechanical strength when cured.
