## Project: Floor Repair and Protection

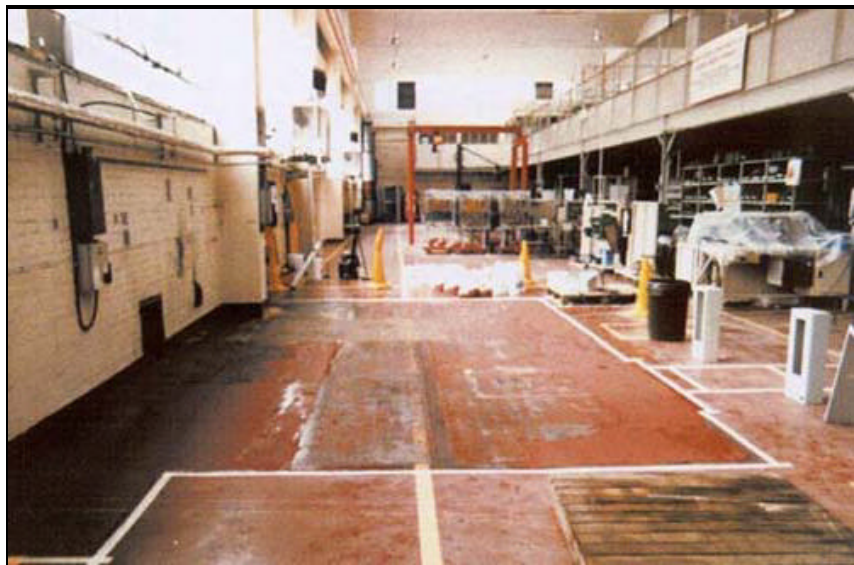
The floor area inside the white border had been identified as an area requiring immediate refurbishment. The existing self-leveling system had begun to fail.

The area to be repaired was treated with **Thortex Floor-Tech SP Primer** and the areas of heavily spalled concrete were filled using a cost-effective system comprising **Thortex Floor-Tech SP Primer** mixed with clean, kiln-dried sand. **Thortex Floor-Tech XSL** was then applied.
