Project: Hydro-Electric Plant

The Problem

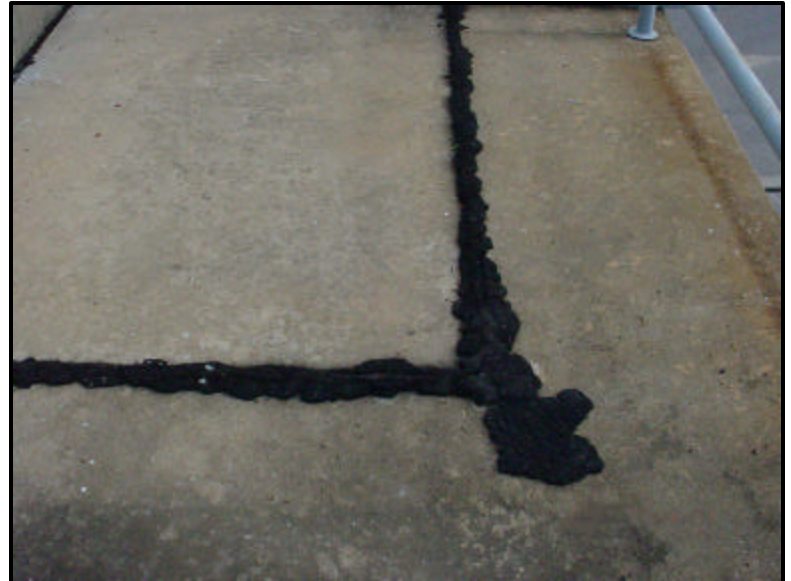
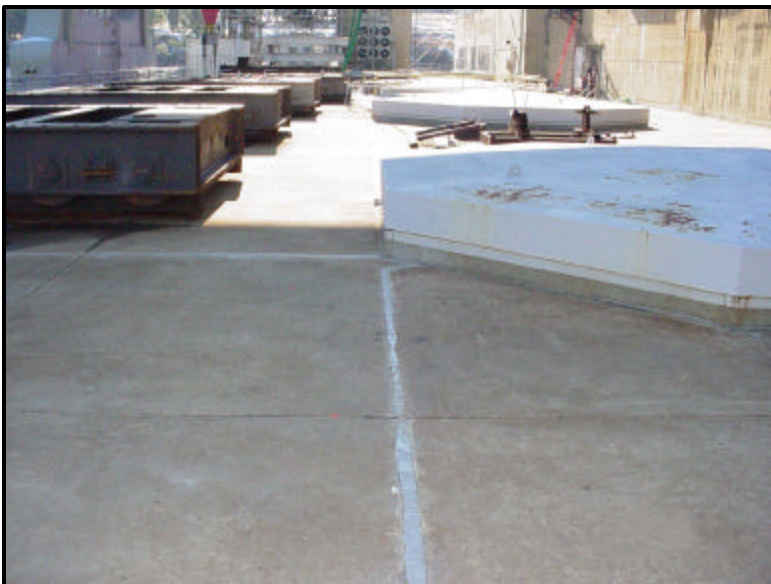
This hydro-electric plant made many repairs to the joints on their turbine deck roof without finding a system that would hold up.

After years of failing joint systems, they called Thortex and RPT for a solution.

RPT removed over 2,500 linear feet of existing 2-inch wide expansion joint material. RPT prepared the walls of the joints and installed **Thortex Flexi-Tech Primer** and closed cell ethafoam rod. RPT then applied **Thortex Flexi-Tech 80 FG**.

This system shows no signs of degradation.
