Project: Tank Farm

The Problem

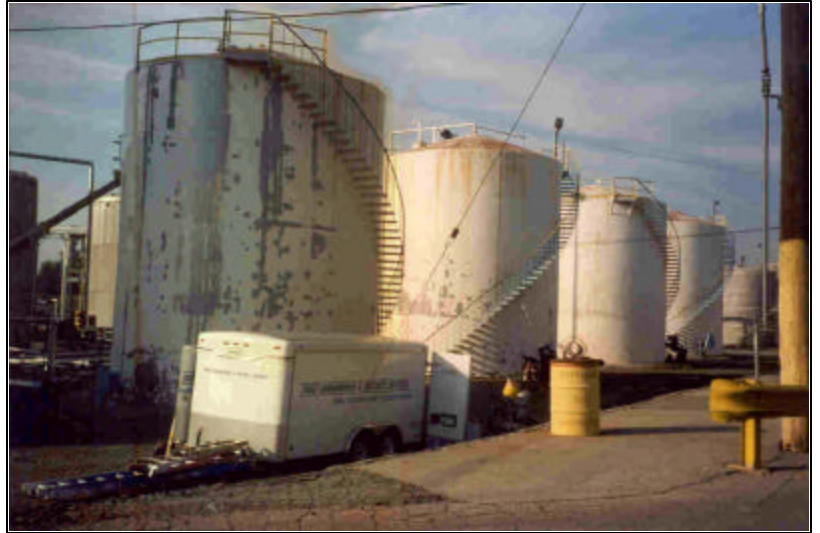
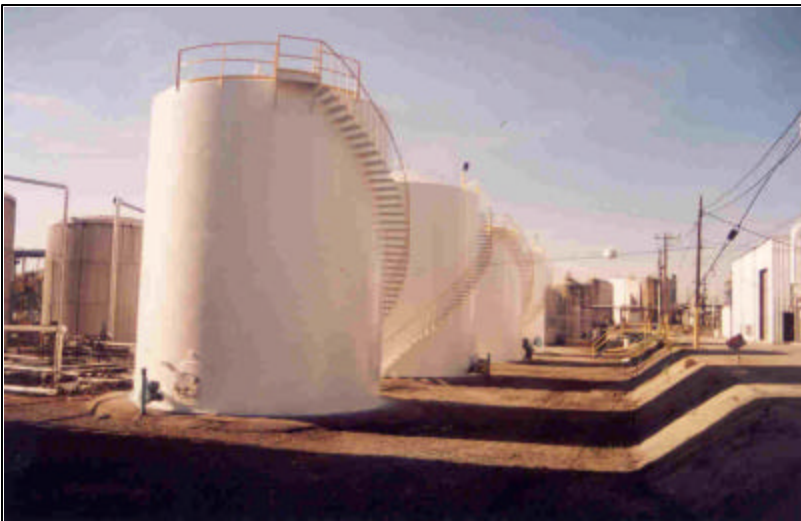
This tank farm was looking for a quick, economical way to improve the appearance of their tanks.

RPT pressure washed and hand tooled the tanks. They were patch primed with **Thortex Corro-Tech GP** followed by two coats of **Thortex Poly-Nox** to the entire surface. This has proven to be a safe and economic solution when abrasive blasting is out of the question.
