## Project: Truck Washdown Area

### The Problem

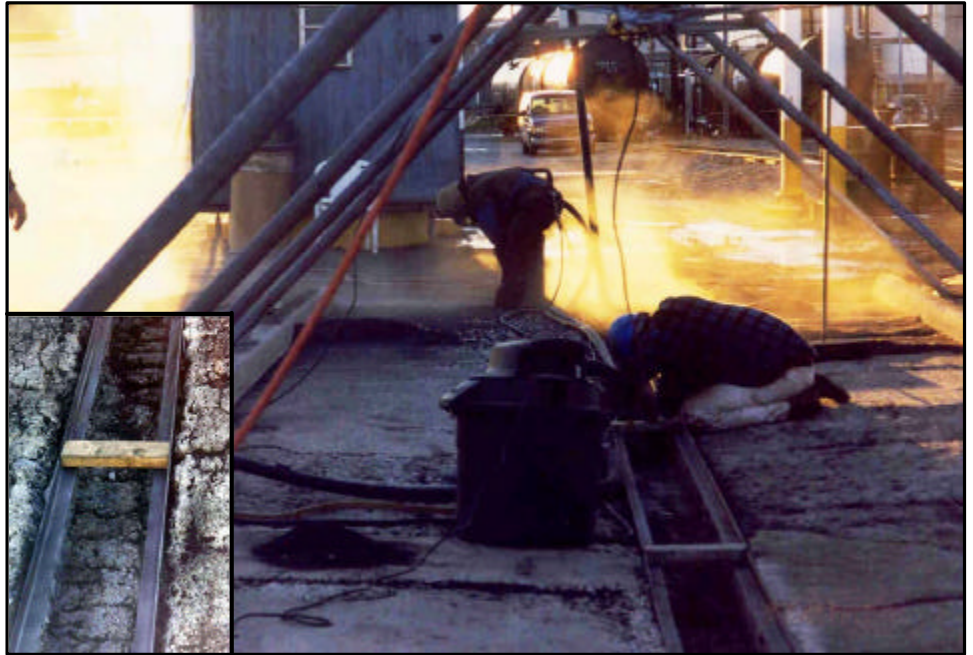
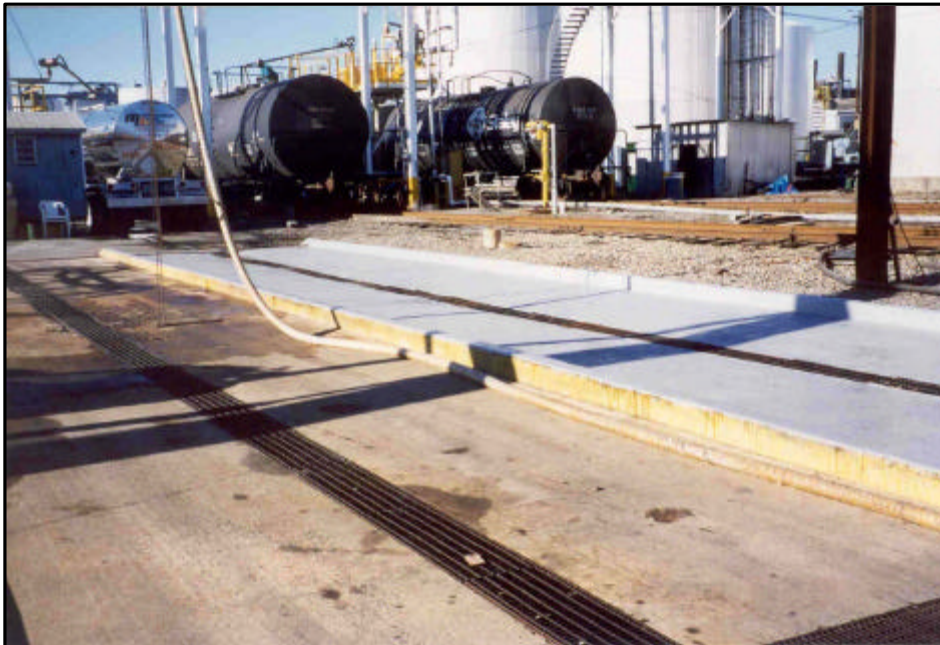
This truck washdown area had seen better days..

RPT was called in to rebuild the concrete surface and trench areas.

RPT applied a degreaser to remove any surface oils and contaminants. Spalled areas were saw cut and all loose aggregate was removed until a solid substrate was reached.

**Thortex Floor-Tech SP Primer** and **Thortex Floor-Tech RS** were used to rebuild the concrete. The base and sides of the existing trench drain system were rebuilt at this time as well.

A coat of **Thortex Floor-Tech SP Primer** was applied to the repaired surfaces followed by two (2) coats of **Thortex Chemi-Tech CR** with a slip-deterrent aggregate incorporated into the first coat of **Thortex Chemi-Tech CR**.
