Project: Tunnel Refurbishment

The Problem

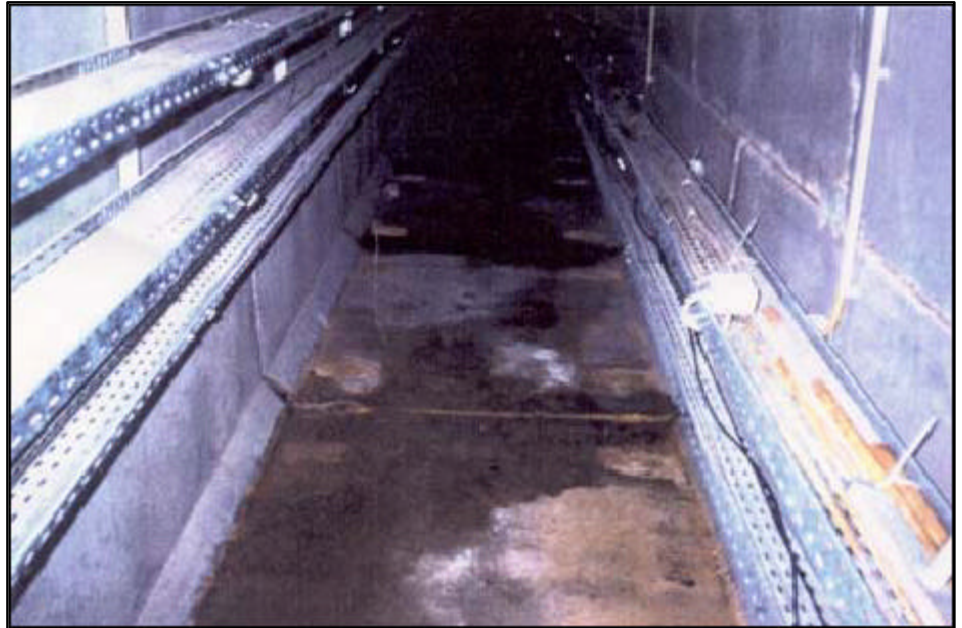
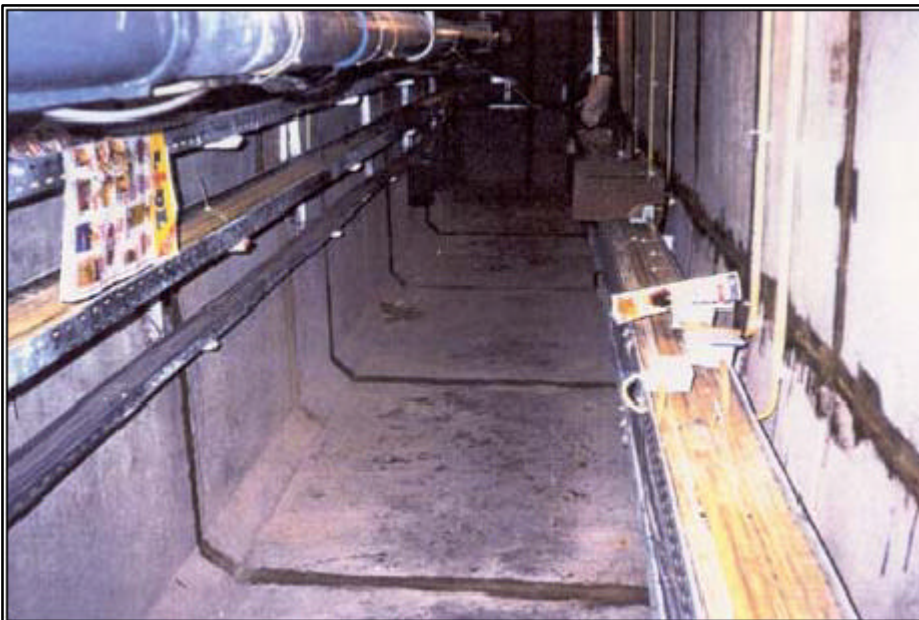
This underground tunnel carries cables under a shopping mall. Problems were developing because of water ingress and high humidity.

The high levels of humidity within the tunnel were affecting the cables and causing major problems in the mall itself.

The floor and wall areas were treated with **Thortex Wall-Tech CWC**. This was where water penetration was occurring.

All joints were primed and filled with a mixture of **Thortex Flexi-Tech Primer** and **Thortex Seal-Tech SS**.

In total, almost 900 linear feet of tunnel was treated and the application system has been a great success.
